> Re: Municipal Storm Water Inspection Report, CDPES Permit Number – COS000003

# City of Aurora Phase I MS4 Inspection Report Colorado Discharge Permit System, Permit #: COS000003

Inspection Dates: August 8, 2012 – August 10, 2012

Prepared by PG Environmental, LLC for the U.S. Environmental Protection Agency Region 8 NPDES Enforcement Unit

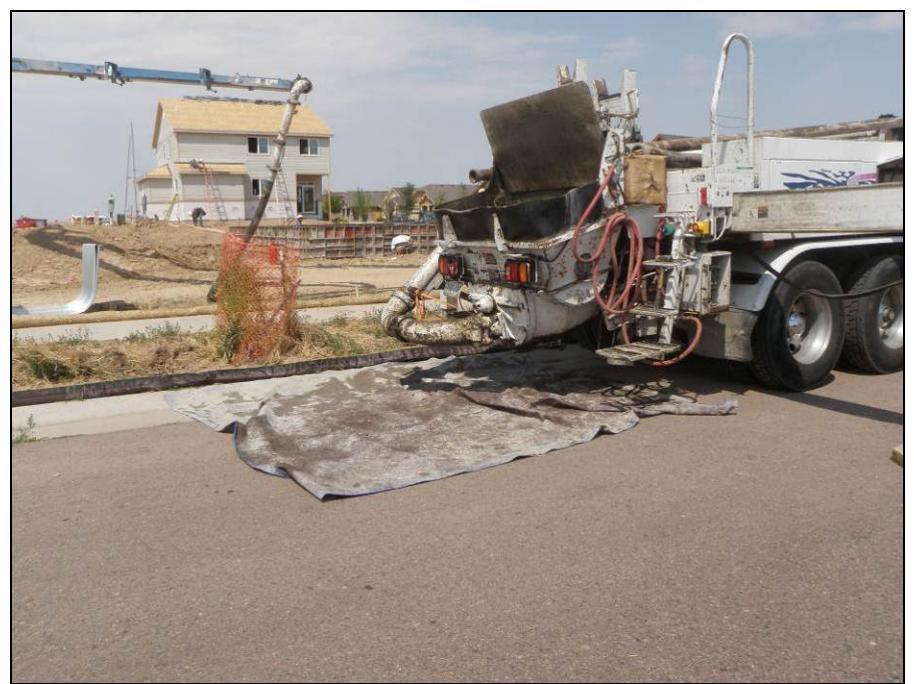
**Photograph 1.** View facing north at staging area for constructionrelated activities at the DR Horton at Traditions new development. Note the effective use of ground cover to protect the impervious surface from exposure to construction materials.

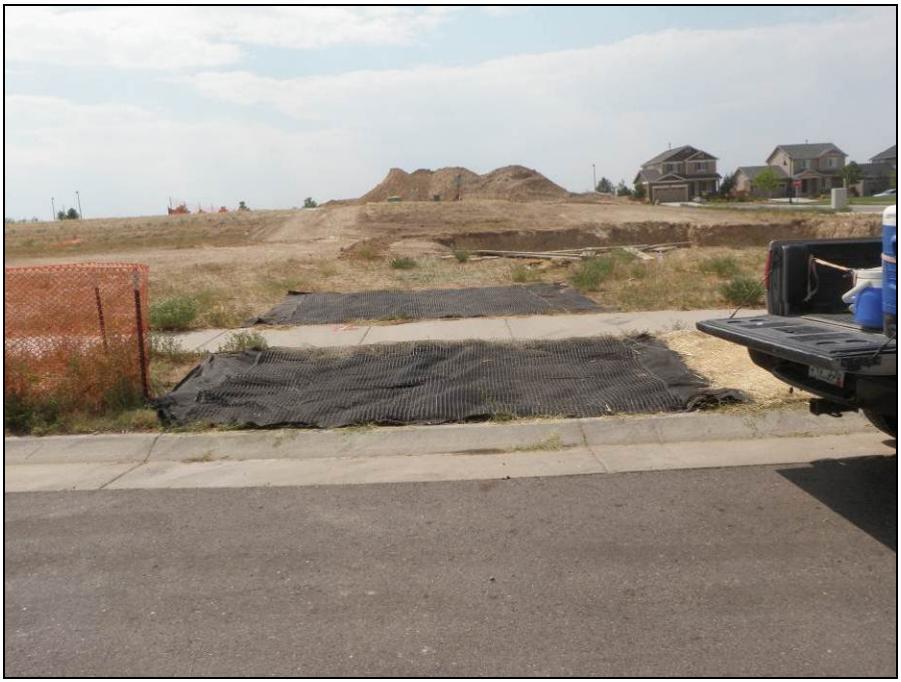
**Photograph 2.** View facing north at an active construction site for the DR Horton at Traditions new development. Note the effective use of plastic to protect the pervious surface from construction vehicles and prevent sediment drag-out from entering the roadway.

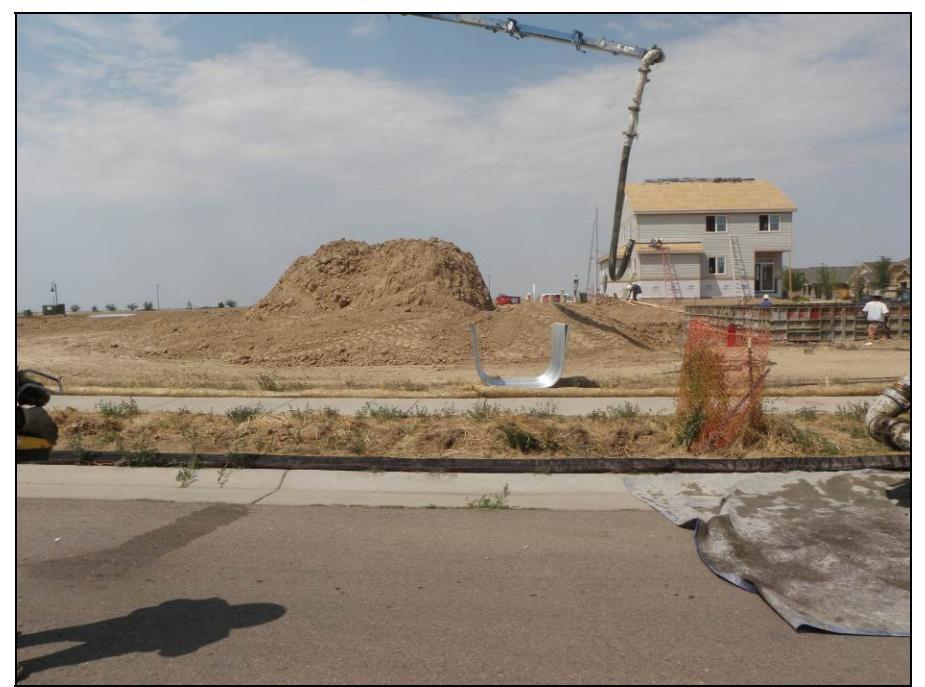
**Photograph 3.** View facing north at the active construction site for the DR Horton at Traditions new development. Note the use of straw bales along the curb to protect sediment drag-out from entering the roadway. In addition, the perimeter of the materials stockpile has been compressed to prevent the mobilization of sediment.

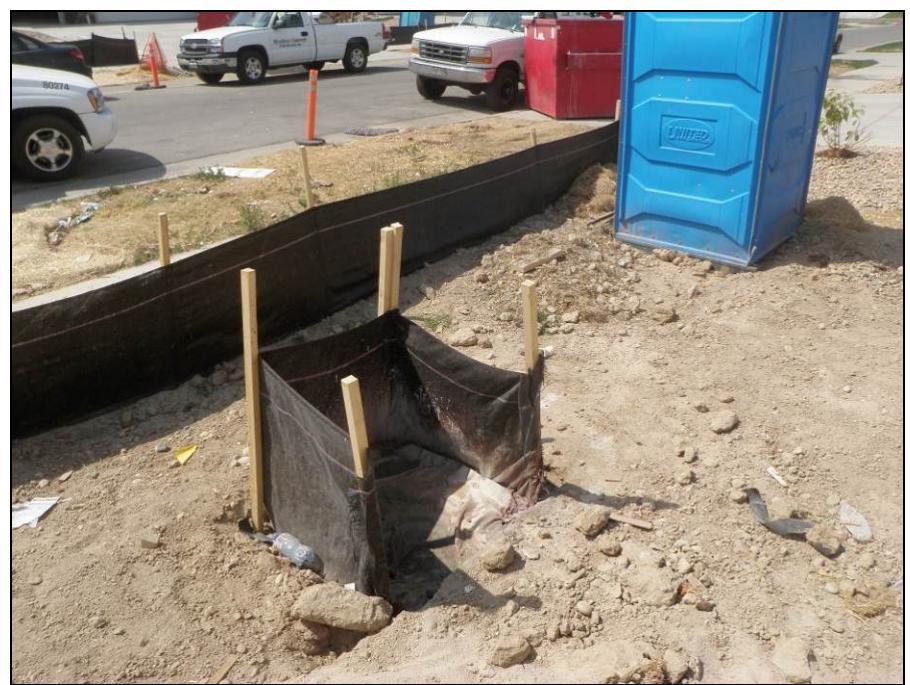
**Photograph 4.** View facing northwest at the active construction site for the Lennar Homes development. Note the use of an effective and innovative BMP to prevent concrete washout from discharging from the site.

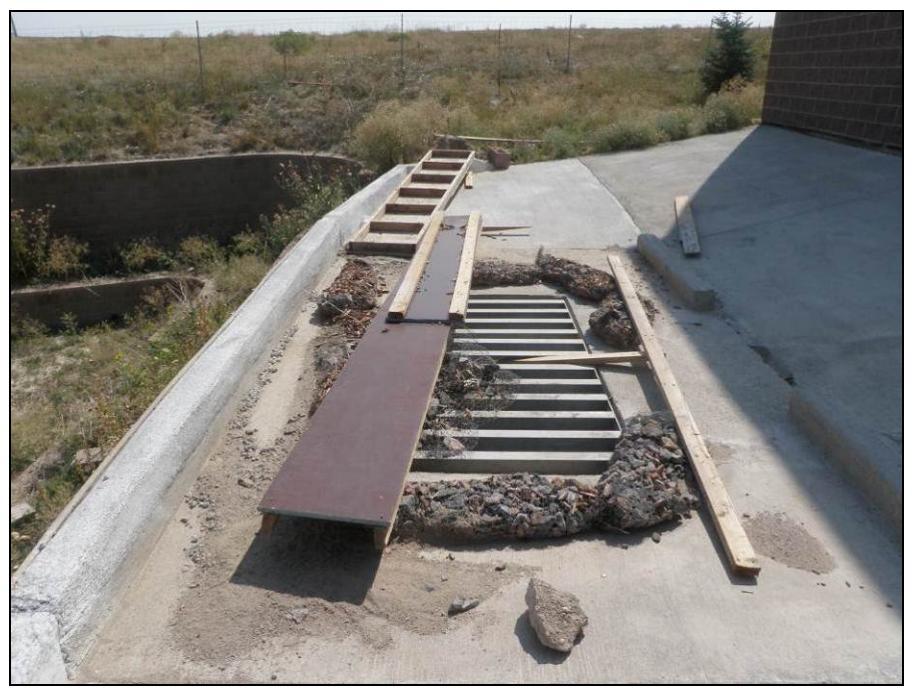
As a component of the inspection, Southlands Self Storage at 5900 South Gun Club Road, one of the sites which had submitted an I&M manual, was evaluated. At the site, the Inspection Team observed construction debris and sediment at the inlet structure south of the pond (refer to Photograph 5). Excessive vegetation and trash were observed within the pond and at the outlet structure (refer to Photographs 6 through 8). The Detention and Water Quality Pond at Southlands Self Storage's Operations and Maintenance Manual's "Debris and Litter Removal" section describes the owner's maintenance obligations and states that "debris closing the outlet structure orifices or inlet grates shall be removed immediately." It was clear to the Inspection Team that the inlet to the pond had not been maintained to the standard set forth in the I&M manual.

**Photograph 5.** View facing east at the stormwater drain leading to the detention and water quality pond at the Southlands Self Storage. Note the accumulation of sediment and construction debris that has not been removed.

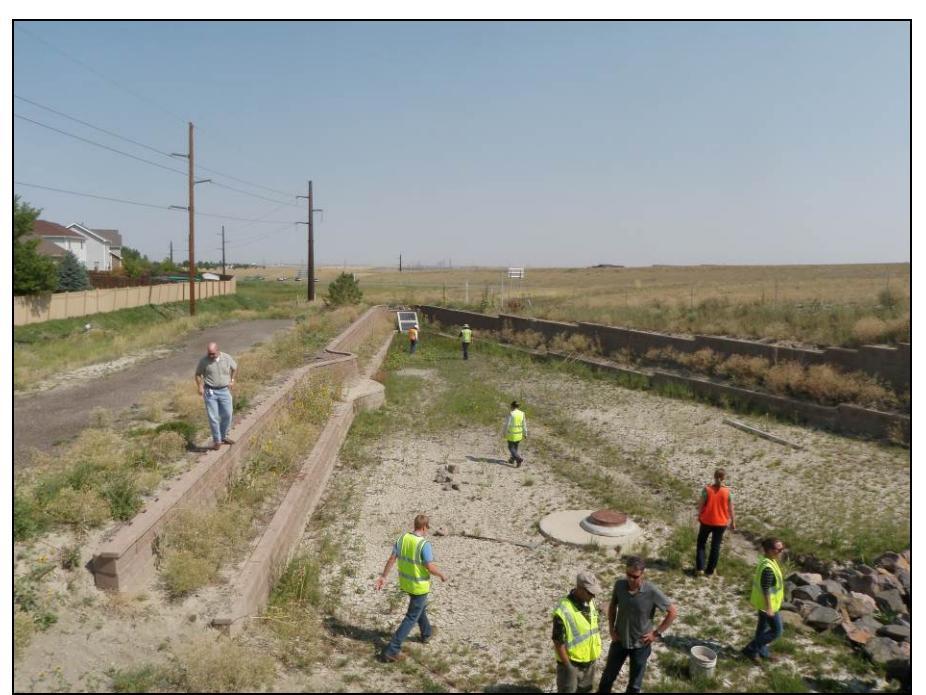
**Photograph 6.** View facing north at the detention and water quality pond at the Southlands Self Storage.

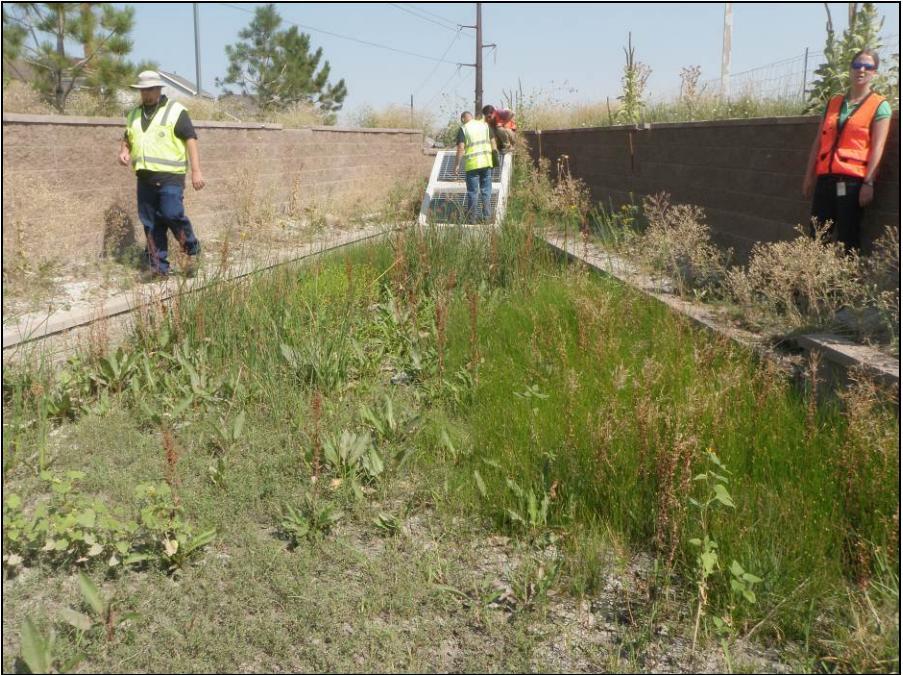
Photograph 7.Close-up view facing north at the the detention andwater quality pond outfall at the Southlands Self Storage.

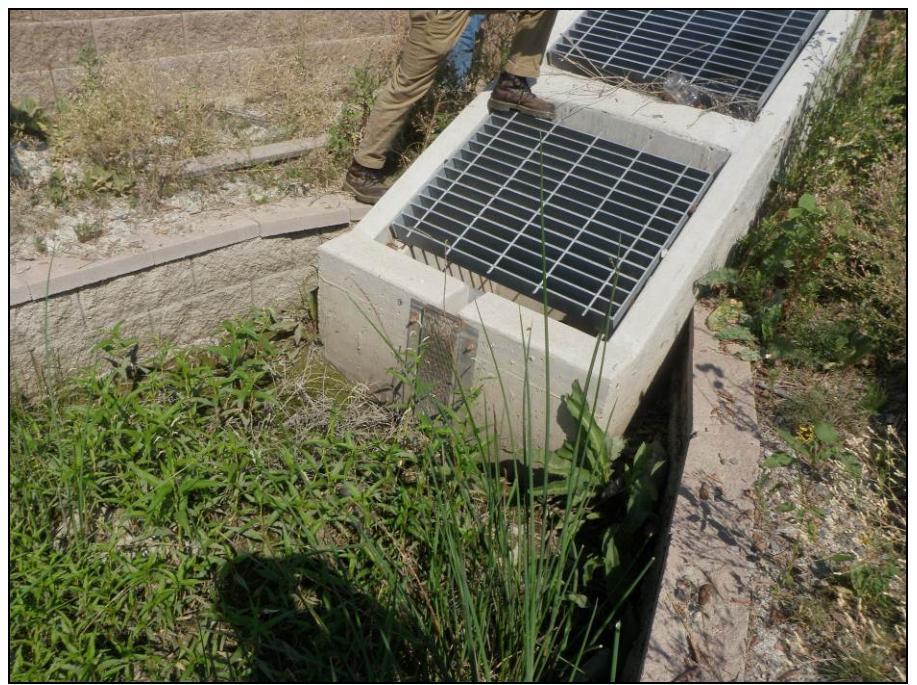
**Photograph 8.** Close-up view facing northwest at the detention and water quality pond outfall at the Southlands Self Storage.

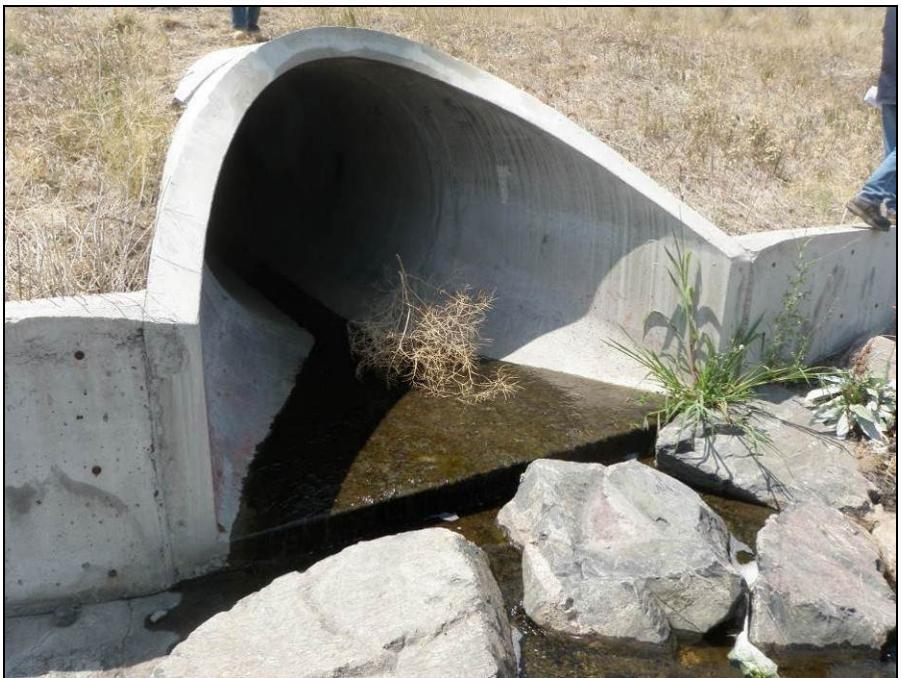
For these reasons, the Inspection Team observed that the City could not effectively demonstrate through past investigations or records that the ongoing and persistent dry weather discharges observed at the Fitzsimmons Parkway outfall did not include illicit discharges.

**Photograph 9.** View of outfall to Tollgate Creek located to the northeast of Victor Street and Fitzsimmons Parkway. Note the dry weather discharge actively flowing from the outfall during the inspection.

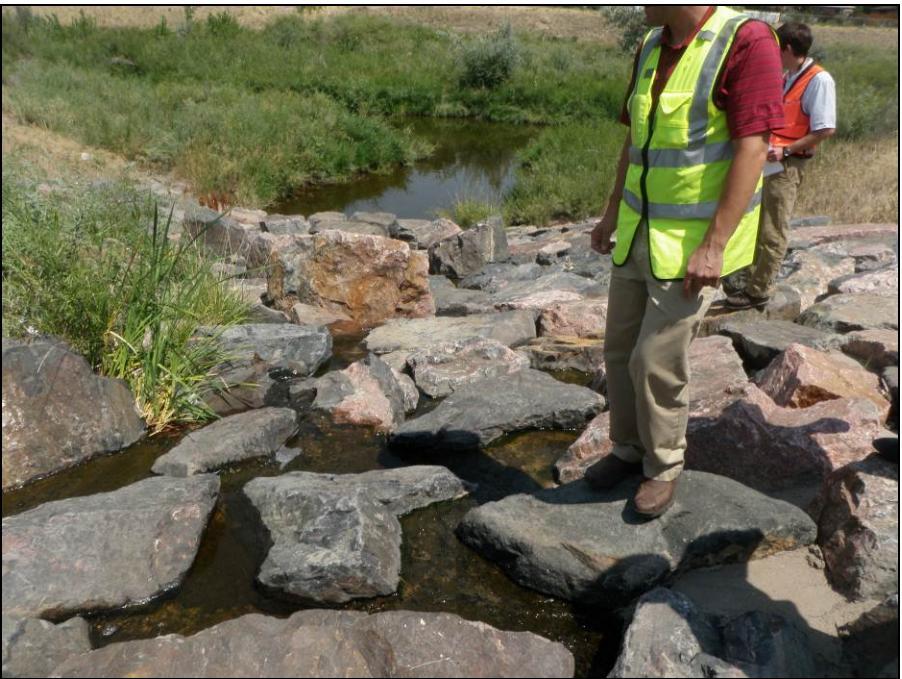
**Photograph 10.** View facing east from outfall to Tollgate Creek located to the northeast of Victor Street and Fitzsimmons Parkway. Note the dry weather discharge actively flowing from the outfall to Toll Gate Creek (receiving water in background).

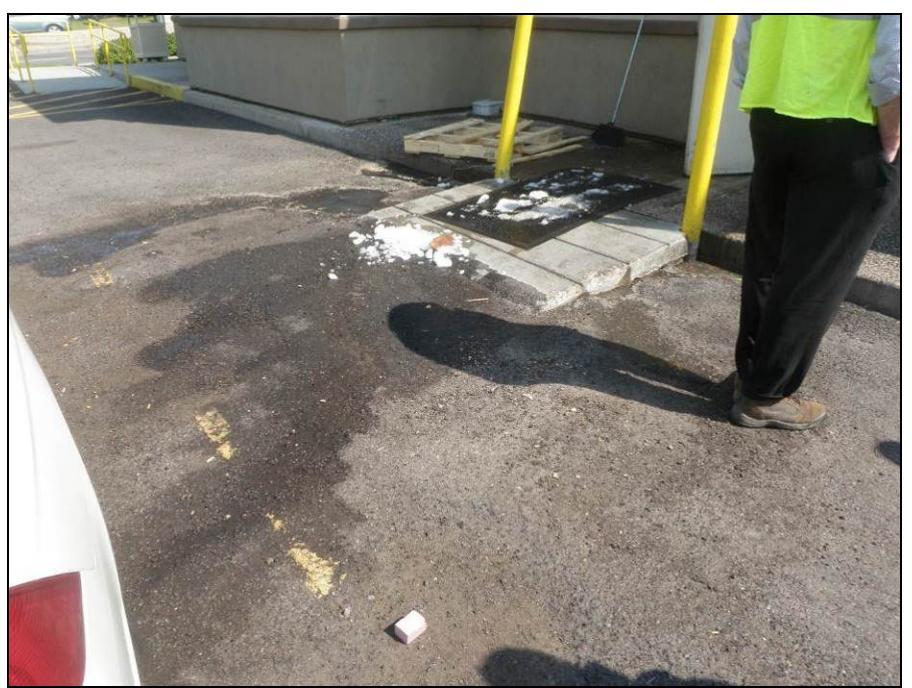
As a component of the inspection, the Inspection Team and City representatives conducted a site visit at a Kentucky Fried Chicken (KFC) restaurant that has a city-permitted grease intercepting device. The Inspection Team observed an employee of the fast food restaurant discharging ice from its walk-in freezer onto the impervious surface outside the restaurant (refer to Photographs 11 through 13). The melting ice appeared to contain food particulates from a floor mat. The pavement in the area exhibited staining indicating the observed discharge, or other discharges, were recurring events. The City Operations Compliance Division inspector observed the discharge but did not immediately address the illicit discharge or question and stop the employee. The City inspector addressed the discharge only when prompted by the Inspection Team.

**Photograph 11.** Close-up view of an illicit discharge from a fast food restaurant at the time of the inspection. A restaurant employee was scraping off ice and other debris from a floor mat onto the impervious surface of the parking lot.

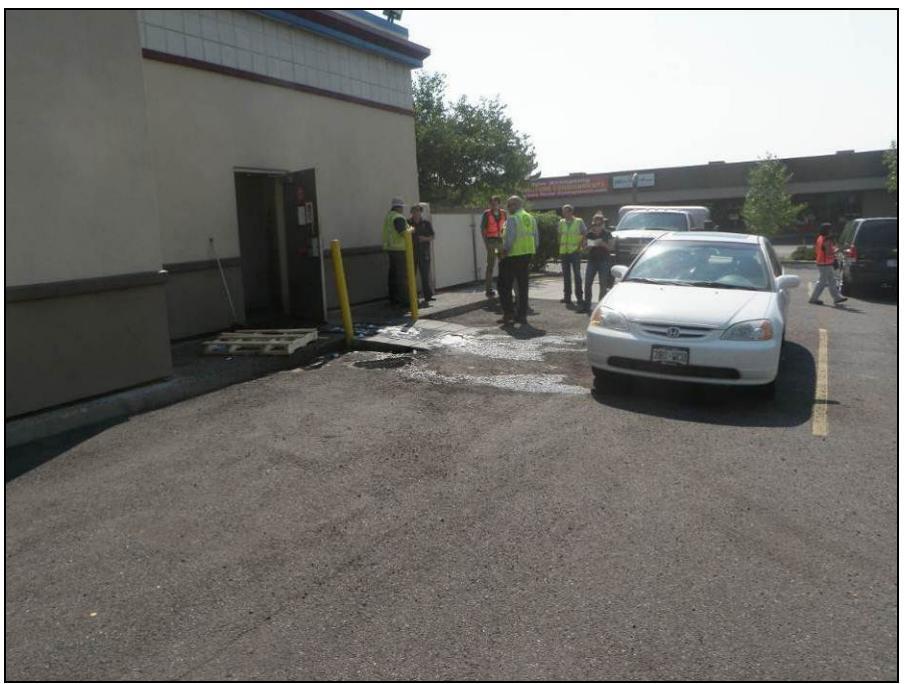
**Photograph 12.** View facing west at the illicit discharge on the impervious surface to the left of the white vehicle.

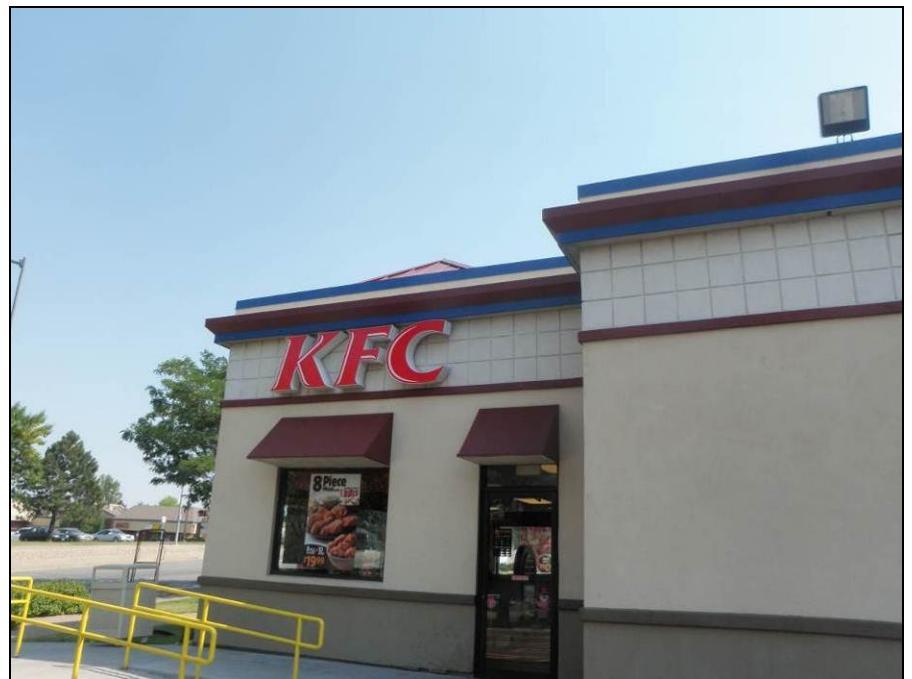
**Photograph 13.** Sign of the fast food restaurant which experienced an illicit discharge at the time of the inspection.

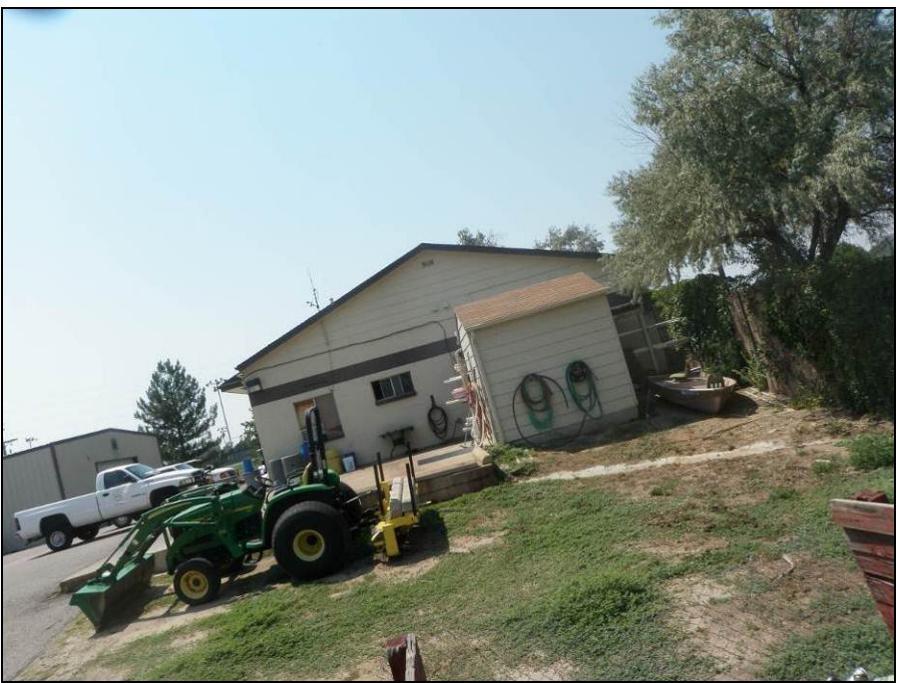
A site visit of the Aurora Hills Golf Course maintenance facility was conducted as a component of the inspection. There was an equipment washing area that consisted of a concrete pad in the northern portion of the maintenance area (refer to Photograph 14). It was observed that the wash and rinse waters from the equipment washing area drained off the concrete pad, through a vegetated area, and ultimately discharged offsite to the Highline Canal (refer to Photograph 15). Equipment wash water is a prohibited discharge and should be classified as an illicit discharge. Prior inspections conducted by the Operations Compliance Division had noted the discharge as a problem and the City inspector had requested that the maintenance facility limit mowing in the drainage area (refer to Exhibit 5 and Exhibit 6 in Appendix B). During the inspection, City representatives stated that they believed the vegetation provided adequate treatment for the wastewaters.

**Photograph 14.** View facing west at the maintenace building at the Aurora Hills Gold Course. Note that washwaters from the concrete pad in the center of the picture drain to the right (north) of the picture.

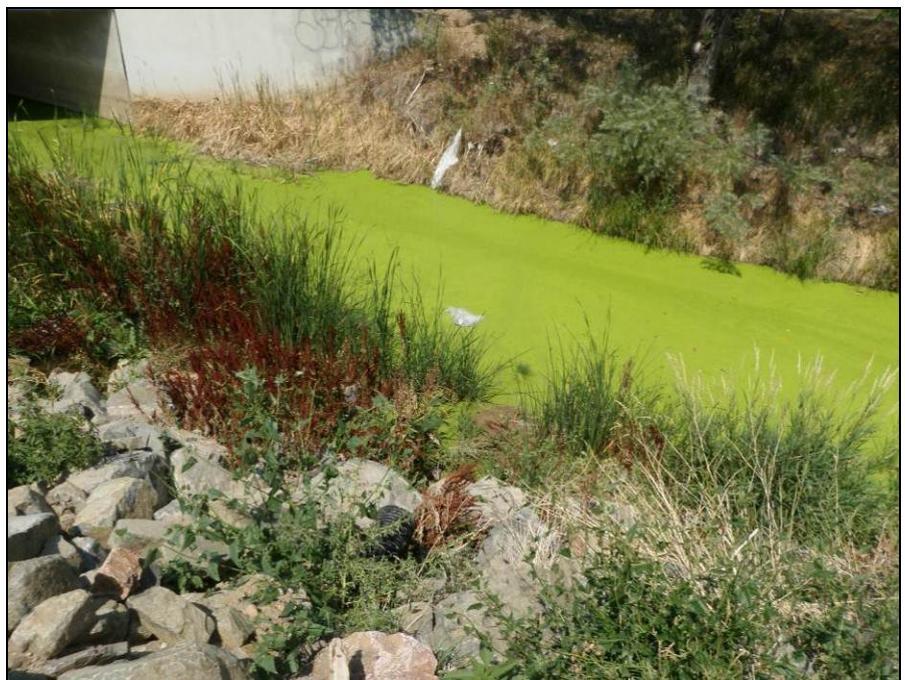
**Photograph 15.** View facing northwest at the High Line Canal located to the north of the Aurora Hills Golf Course. The washwaters from the concrete pad in Photograph 11 discharges to this waterbody.

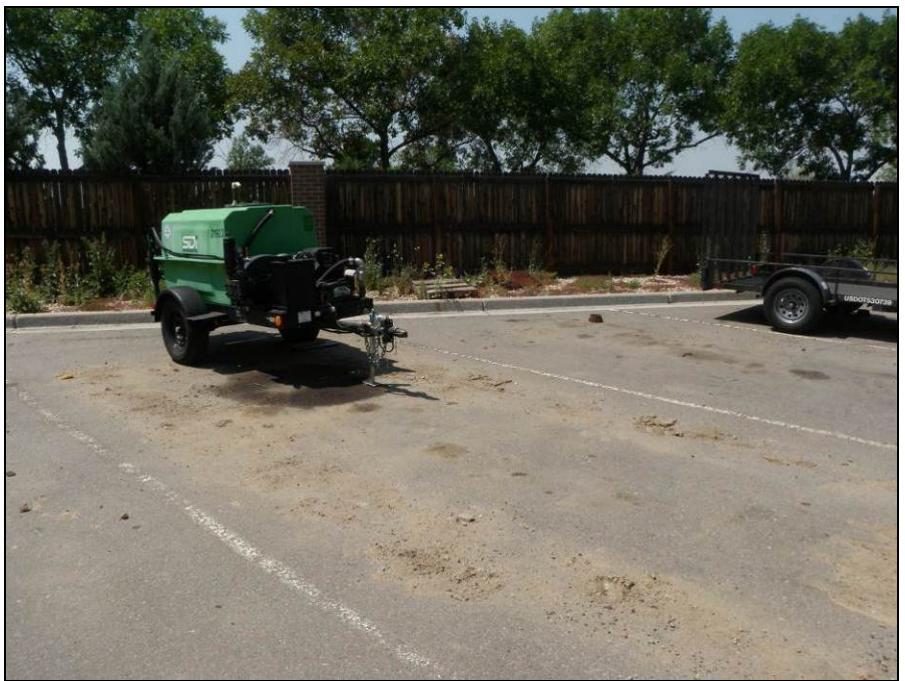
During the inspection, the Inspection Team observed several large petroleum product stains on the impervious surfaces at the motor pool of the City's Central Facility (refer to Photographs 16 through 18). The City representatives stated that vehicles and machinery in need of maintenance are stored outside in this area prior to receiving required maintenance. In addition, the Inspection Team observed a stain of unknown substance on the impervious surface, adjacent to the Parks and Open Space building at the Central Facility (refer to Photograph 19). At both locations spill prevention and response procedures did not appear to have been implemented. For example, BMPs such as, but not limited to, drip pans and absorbent material were not observed in the damaged vehicle/equipment staging area.

**Photograph 16.** View facing northwest at outdoor storage area for vehicles in need of repair. Note the petroleoum product staining on the impervious surface underneath the generator.

The City needs to appropriately address existing spills and provide additional BMPs and guidance at the motor pool. The Parks and Recreation portion of the yard needs to improve housekeeping procedures to minimize pollutant exposure and address the deficiencies previously identified in Operations Compliance Division inspection reports. Provide the EPA and CDPHE, the City's plan to address this finding (including the resources and timeframe). Ensure any plans or other documents that are required to be updated/submitted to CDPHE, per the permit, as part of any programmatic updates are submitted to CDPHE.

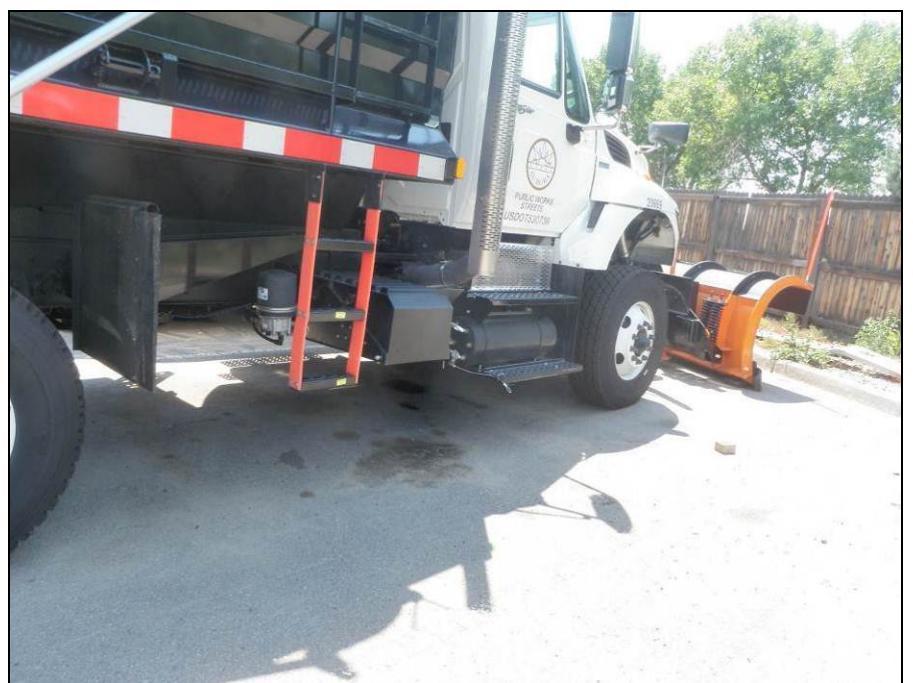
**Photograph 17.** View facing southwest at petroleum product staining on the impervious surface underneath a stored vehicle. Note the lack of spill response BMP implementation.

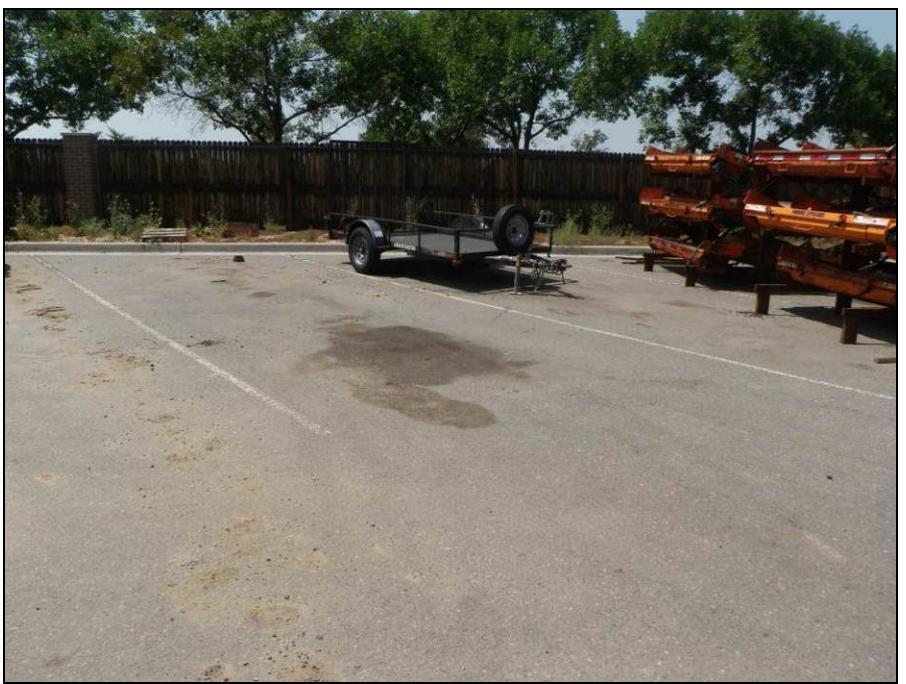
**Photograph 18.** View facing northwest at outdoor storage area for vehicles in need of repair. Note the petroleoum product staining on the impervious surface and lack of spill response BMP implemention.

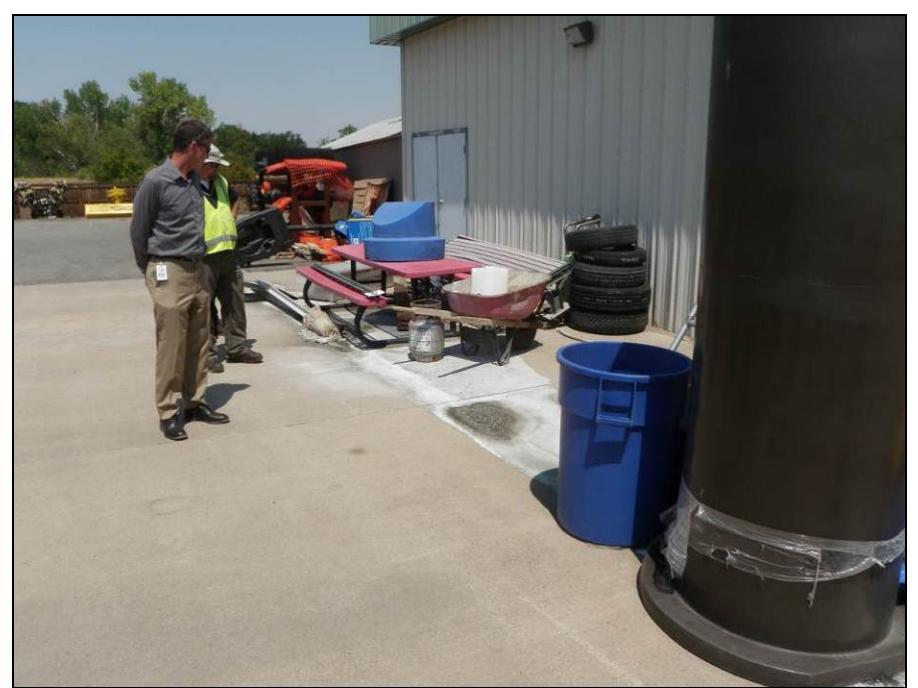
Photograph 19.View facing northeast at stain of unknownsubstance on the impervious surface to the west of the Parks and RecreationStorage building at the Central Facility. Note the lack of spill responseBMPs implemented.

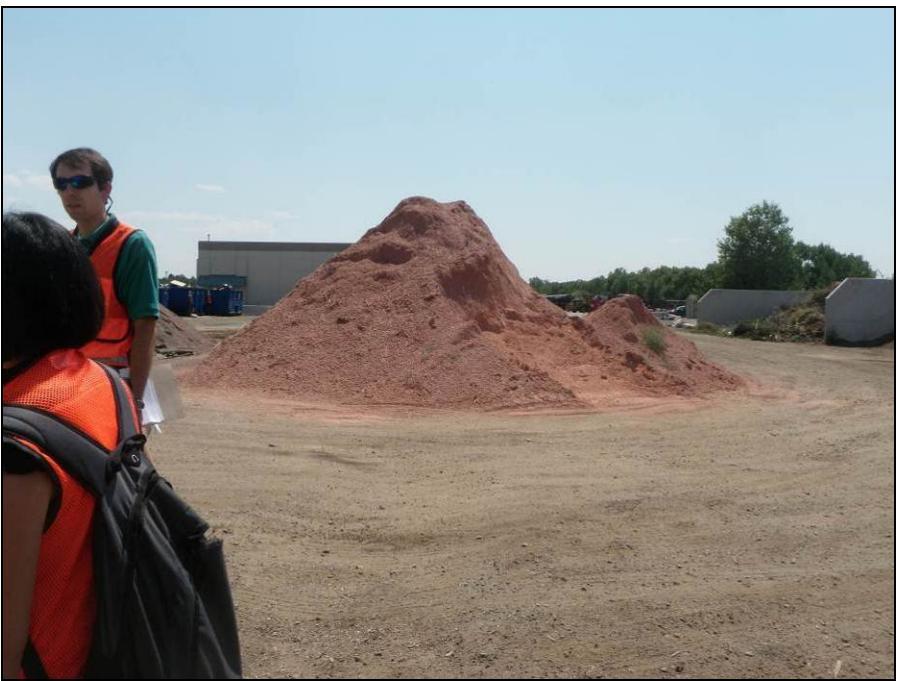
**Photograph 20.** View facing south at pile of stored landscaping material at the Central Facility. Note the lack of erosion and sediment control BMP implementation.

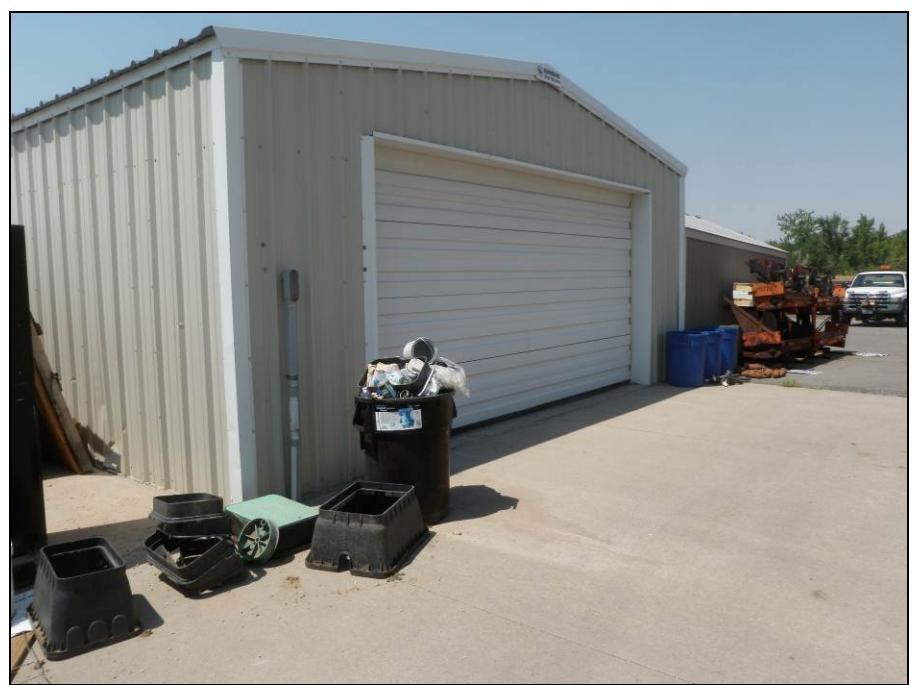
**Photograph 21.** View facing northwest at a storage area to the east of the Parks and Recreation Storage building at the Central Facility. Note the lack of good housekeeping BMPs implemented to manage the disorganized collection of equipment and the overflowing trash container.

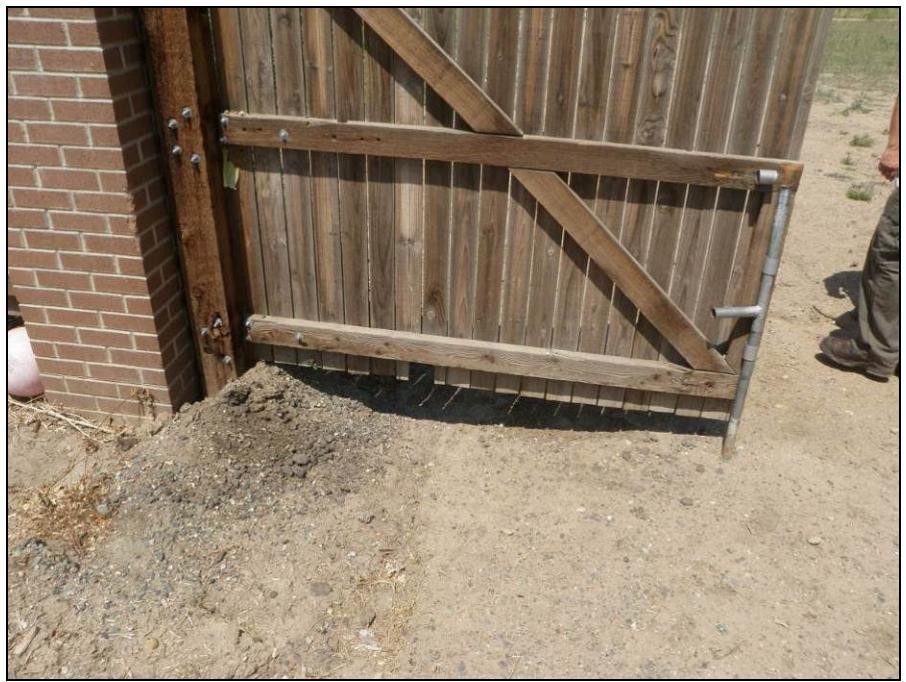
**Photograph 22.** View facing gate leading from a sediment covered storage area to the Central Facility's stormwater retention pond.

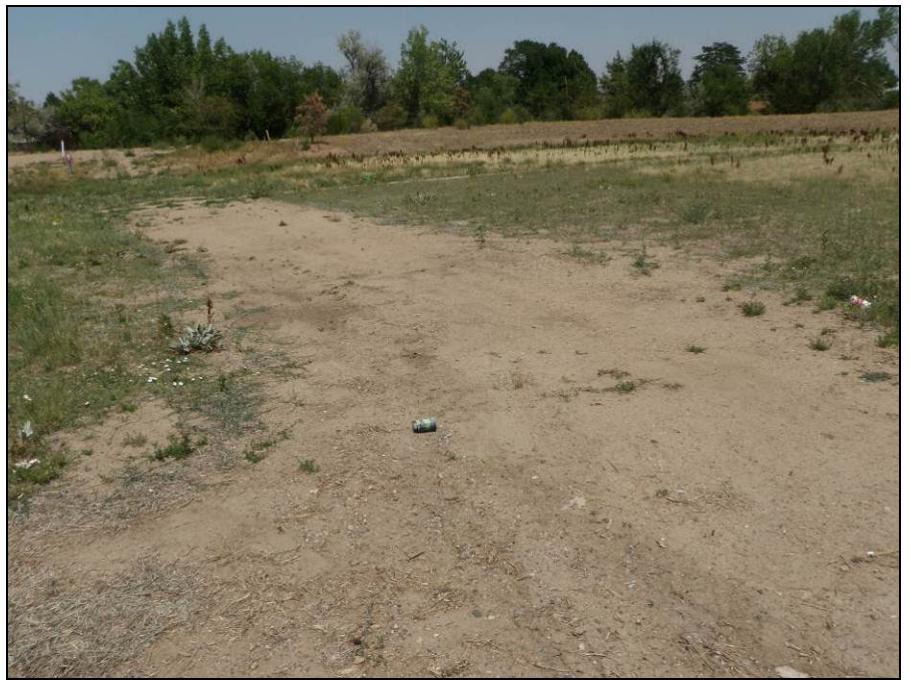
Photograph 23.View facing north at an unstabilized portion of theCentral Facility's stormwater retention pond.
