> Re: Municipal Storm Water Inspection Report, CDPES Permit Number – COS000003

# City of Aurora Phase I MS4 Inspection Report Colorado Discharge Permit System, Permit #: COS000003

Inspection Dates: August 8, 2012 – August 10, 2012

Prepared by PG Environmental, LLC for the U.S. Environmental Protection Agency Region 8 NPDES Enforcement Unit

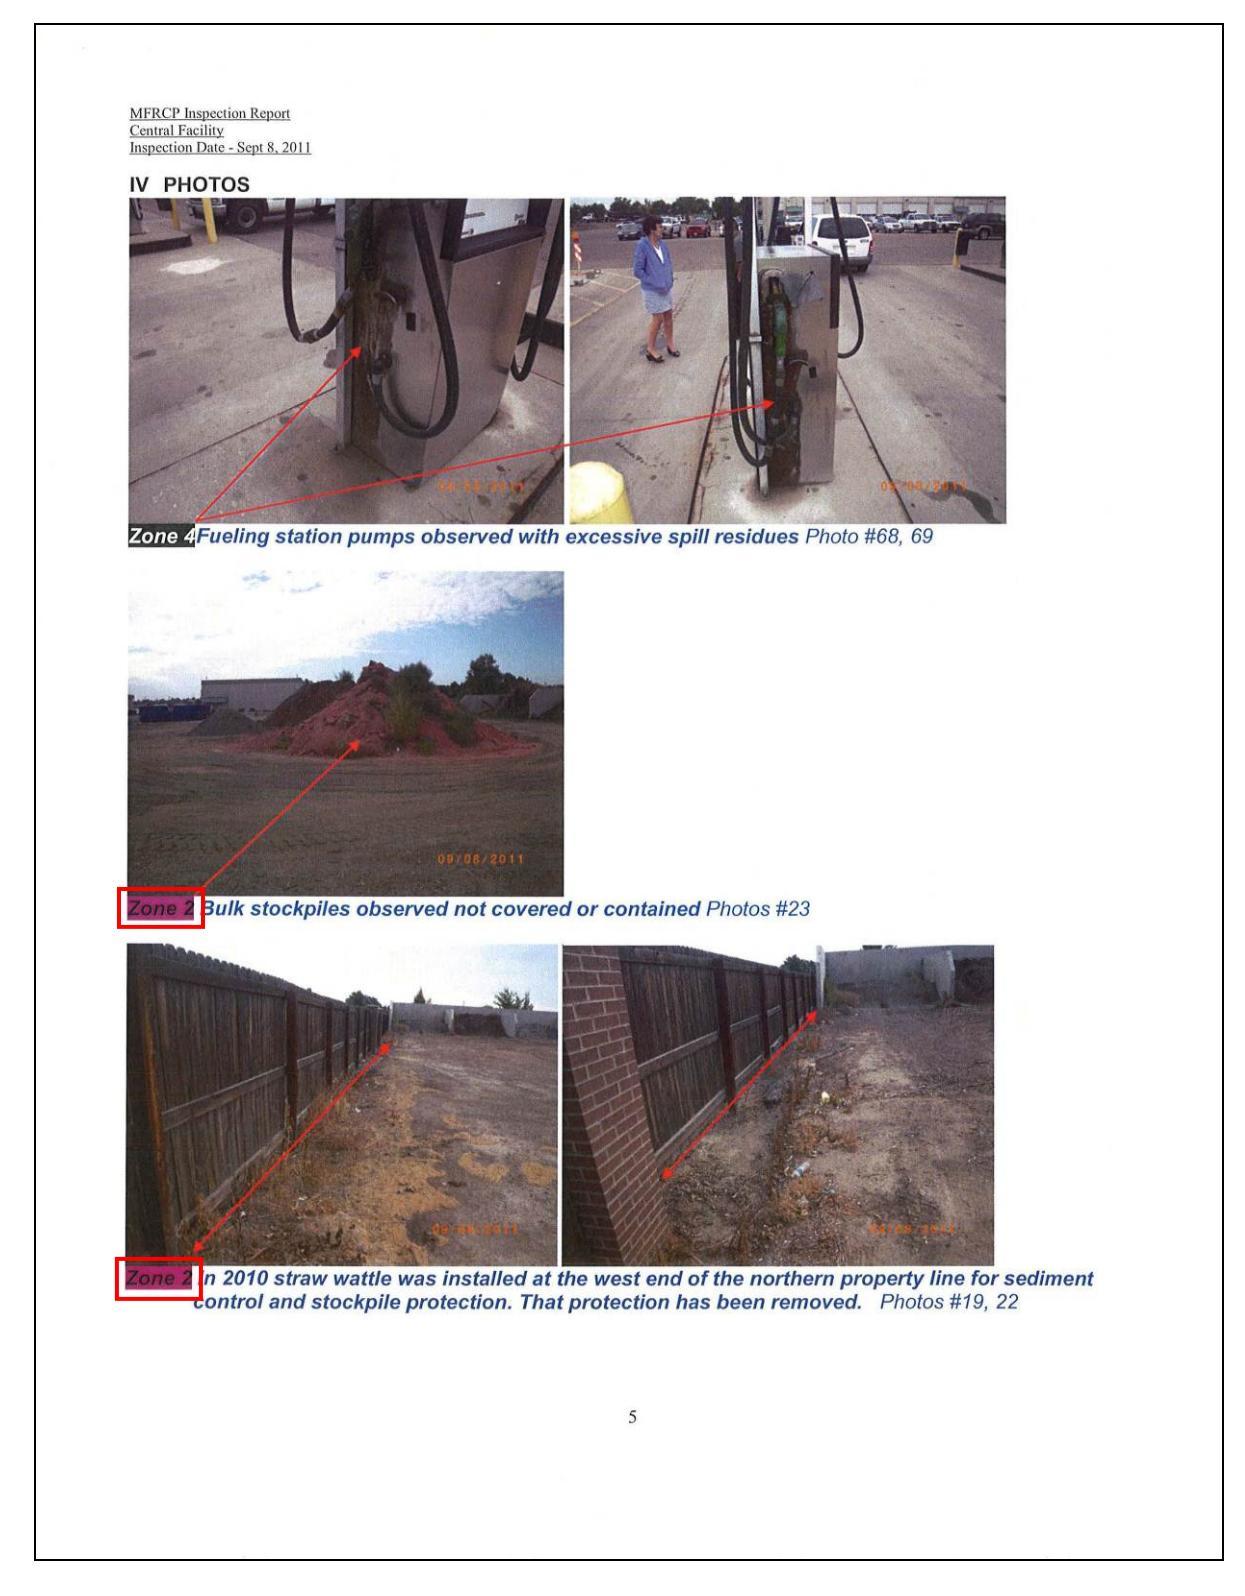
Exhibit 8: Excerpt from the photo log in the Central Facility municipal facility inspection report for the inspection conducted on September 8, 2011. Note: Zone 2 photos are referencing Parks, Recreation and Open Space stormwater deficiencies.
