City of Grand Rapids, MI

STORMWATER ASSET MANAGEMENT AND CAPITAL IMPROVEMENT PLAN

May 2013

STORMWATER ASSET MANAGEMENT PLAN

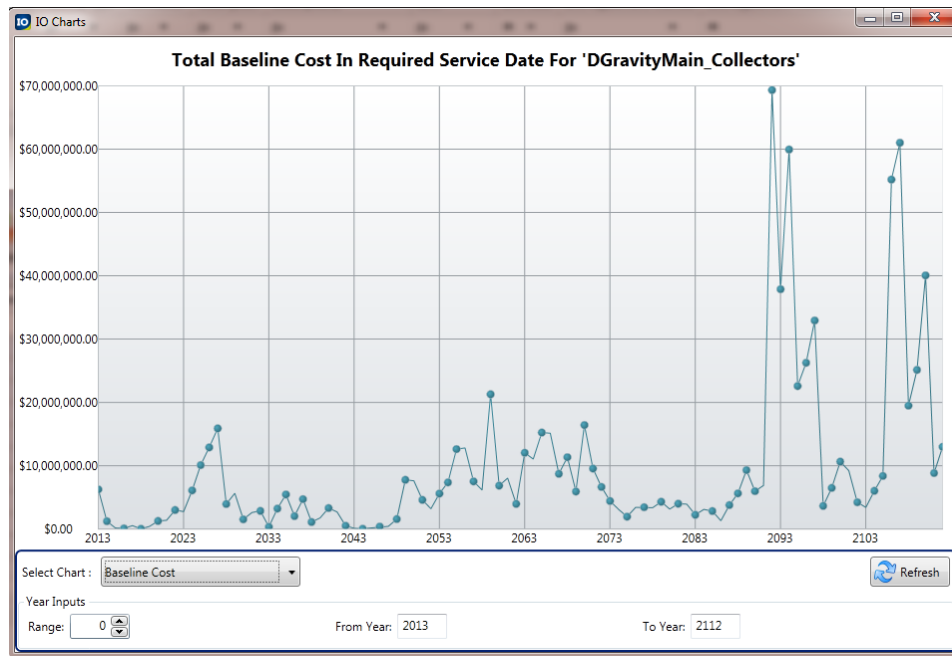
Figure 3-6 Annual Cost to Replace Gravity Mains at End of Estimated Effective Life

Figure 3-6 and Figure 3-7 illustrate the replacement costs per year based on the required service date for a 100-year timeframe. The baseline cost is based strictly on replacement costs, though in many cases pipes will only require rehabilitation or no action at all. The high annual replacement costs observed between 2090 and 2110 are a result of the recent sewer separation program associated with the CSO program.
